2023 Annual Facility Performance Review Report

Duck Pond Operations Tailings Management Facility

Teck Resources Limited

Reference No. 23595269-001-R-Rev0-4100

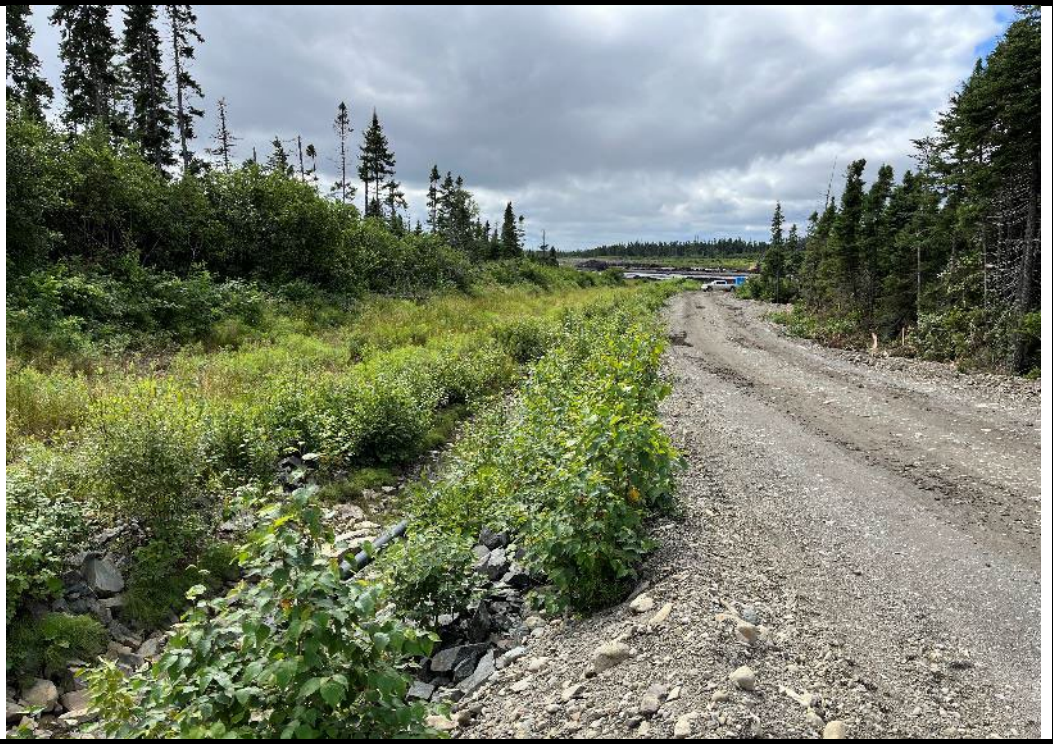
Photograph 4

Discharge Ditch at Sta. 0+250
looking towards the Polishing
Pond.

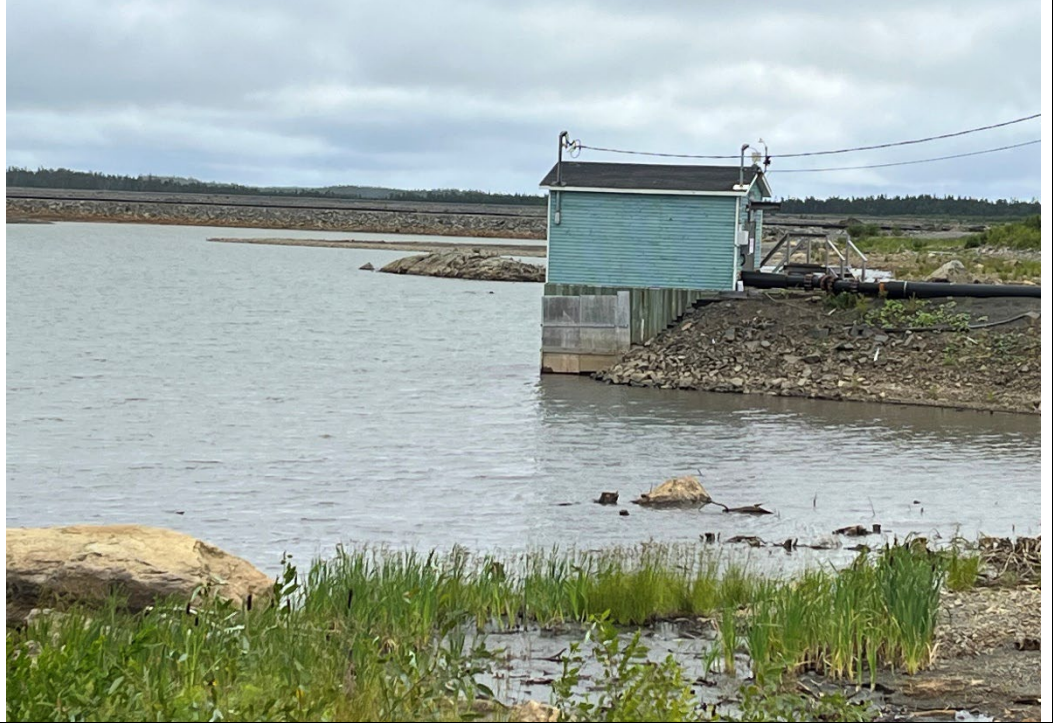
Photograph 1

Water Reclaim Well.

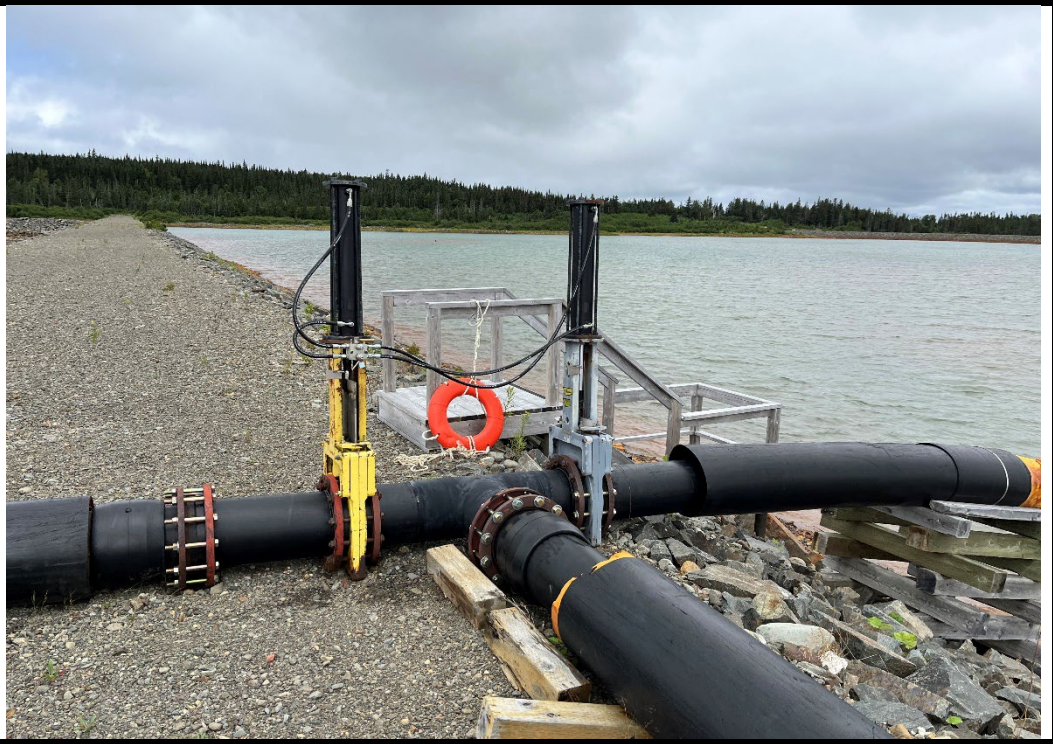
Photograph 2

Pipeline from water treatment plant with T-valve to control flow towards Cells 1 or 2.

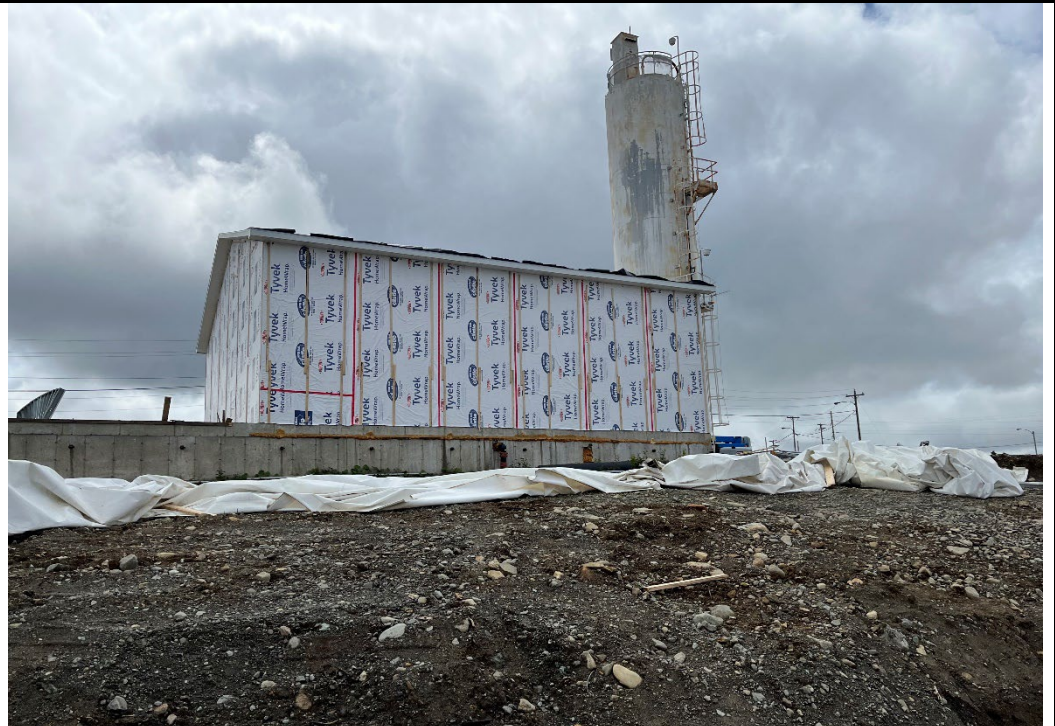
Photograph 3

New water treatment plant building on southern shore of TMA under construction.

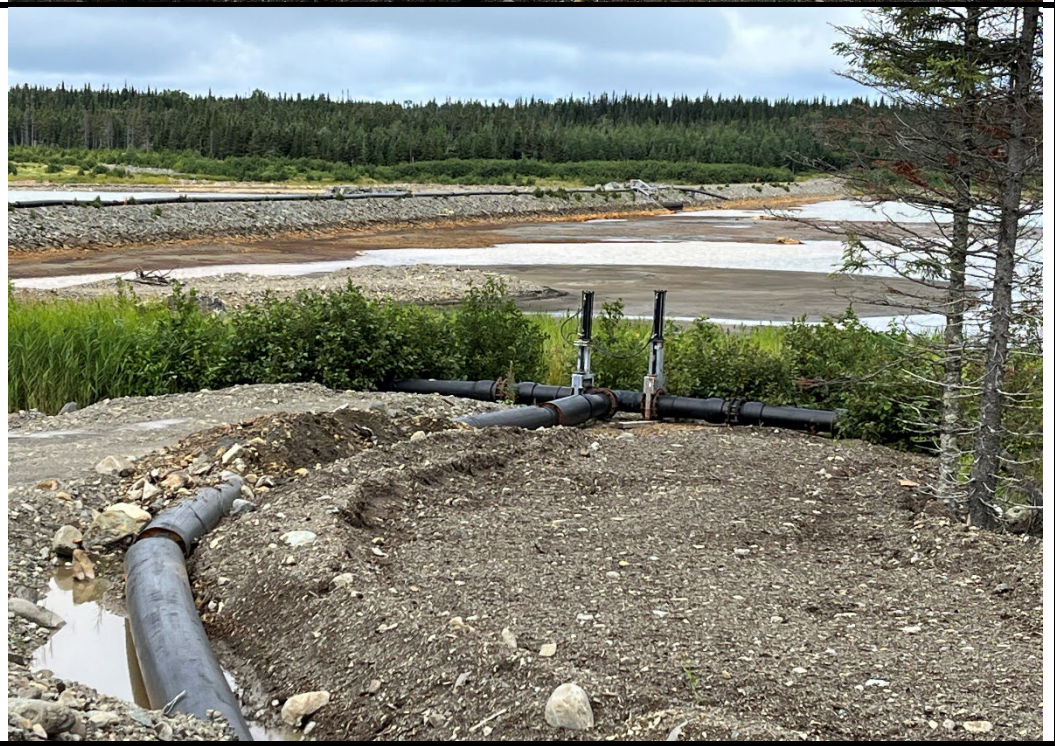
Photograph 4

In 2017 two new pipelines were installed from the water treatment plant to Berms 1 and 3. The pipelines appear to be a combination of 10", 12", and 14" HDPE pipelines with tee valve at the discharge locations to allow flow into all 4 cells (see Photo 4). Teck reports that the pipelines are functioning as required. As the pipelines traverse along the crest of Berms 1 and 3, they were raised above the spillways in 2023 (Photo 5), following recommendations in previous years.

Water treatment plant discharge pipeline with valves to control flow towards Berm 1 or 3.

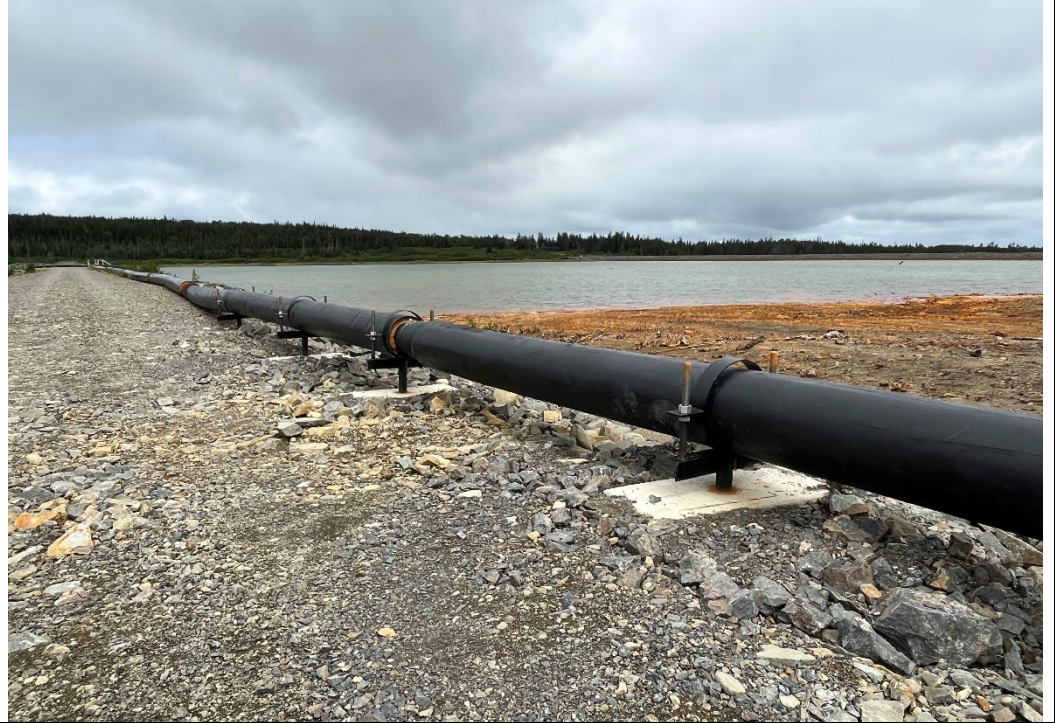
Photograph 5

Water treatment plant discharge pipeline on Berm 1 through spillway. The pipeline was raised in 2023 through the spillway.
