Teck Metals Ltd.

Sullivan TSF 2023

Annual Facility Performance Report

March 26, 2024

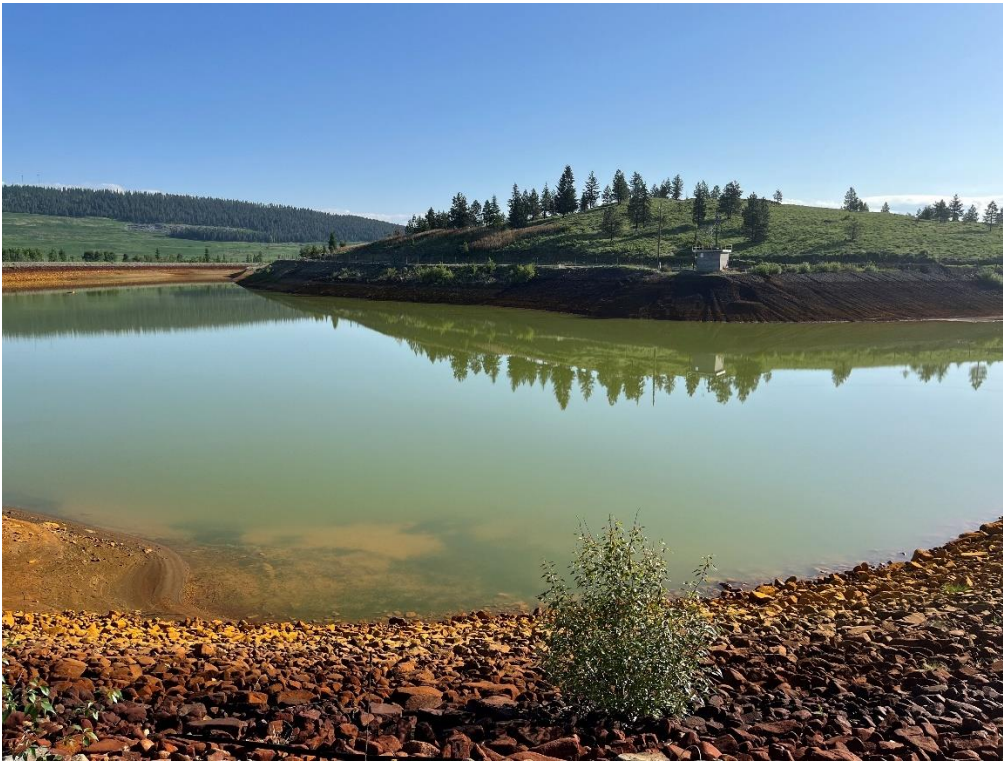
Photo II.3 Erosion adjacent to pumphouse

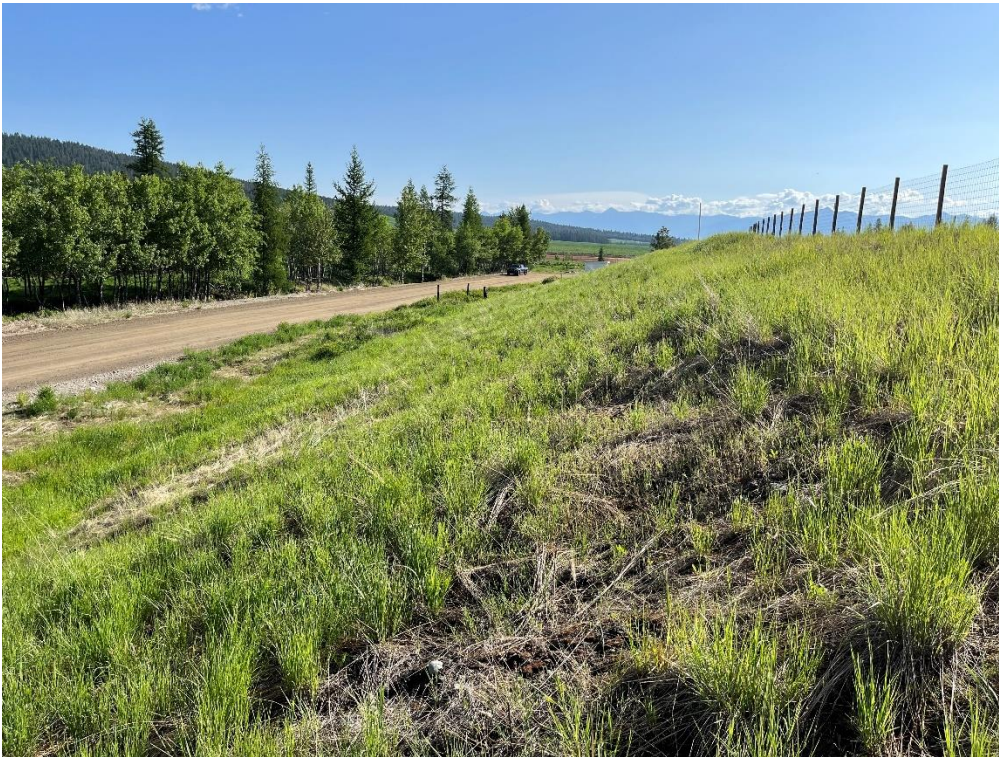
Photo II.5 **Vegetation on slope of North Dam**

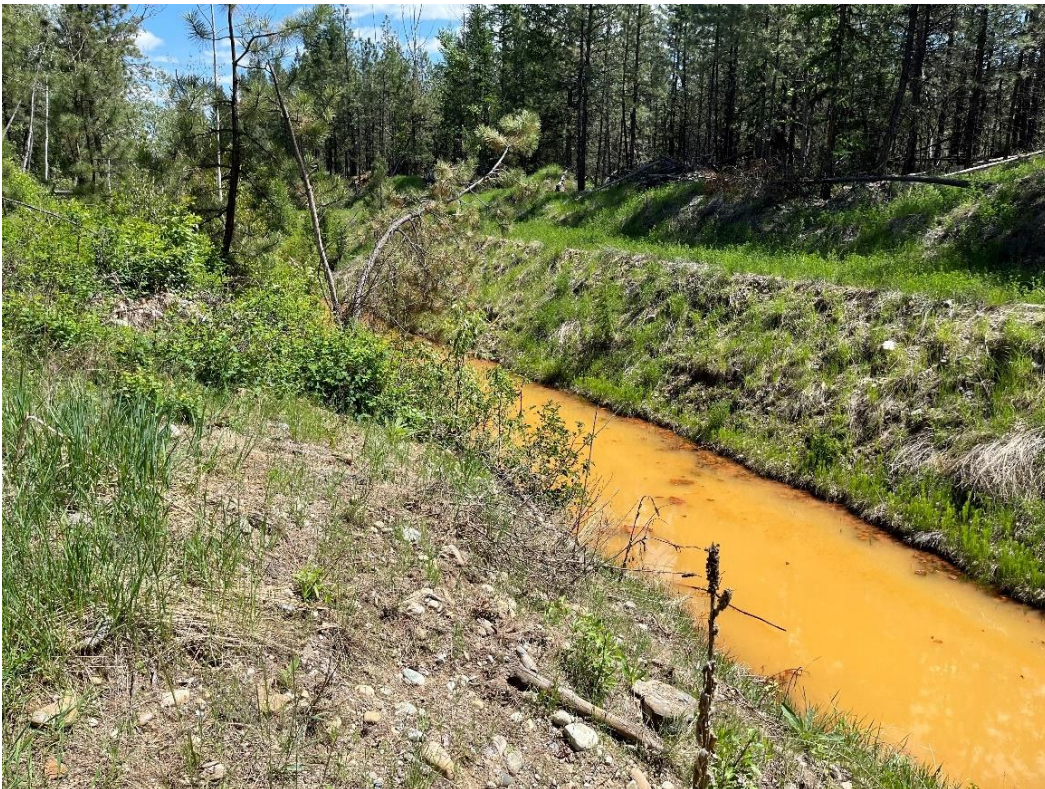
Photo II.24 Seepage downstream of No. 2 Siliceous Dike
